# Hands On: Machine Polishing

**IS YOUR BMW'S PAINTWORK OXIDISED, DULL AND COVERED IN SWIRL MARKS FROM CARELESS PREVIOUS OWNERS? WE SHOW YOU HOW TO RESTORE THE PAINTWORK THE PROFESSIONAL WAY**

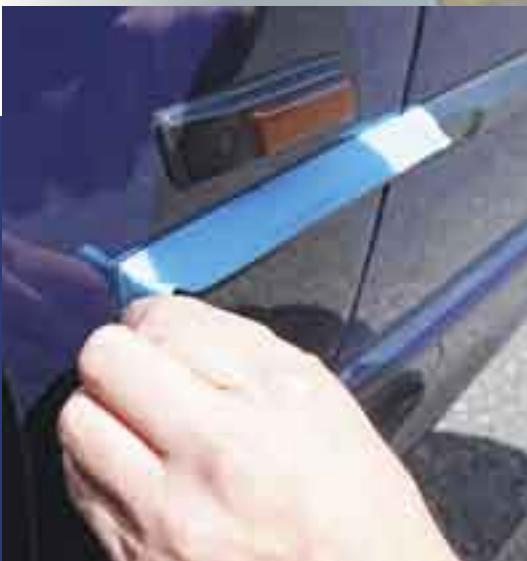
## 01

3M tape was used to protect the door mouldings. Splatter occurs when you use too much product and it pebbledashes the vicinity in tiny specks, which can also stain plastic. A degree of splatter is inevitable, but our application guide should keep it to a minimum.

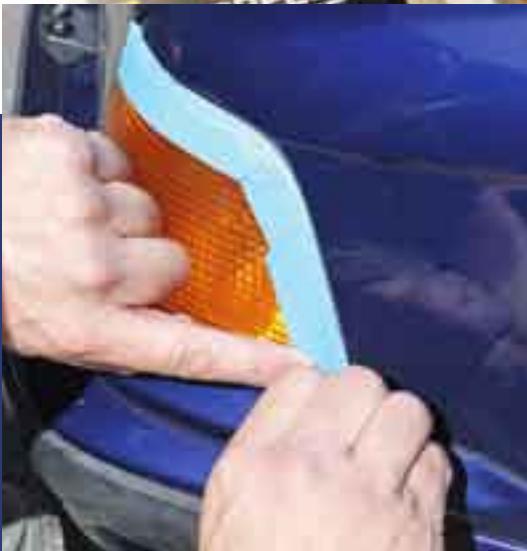
## 02

It's also important to mask up areas such as the indicators for similar reasons. Removing product from the rubber seal is time-consuming, so spending another minute covering vulnerable areas will pay dividends. Remove the roof aerial and mask badges.

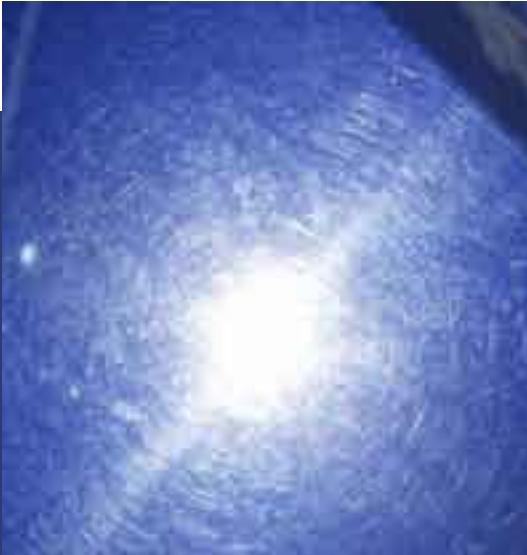
## 03

The swirl marks are exposed more when the sunlight hits them or when parking beneath a fluorescent street light for example. These ones were clearly evident.

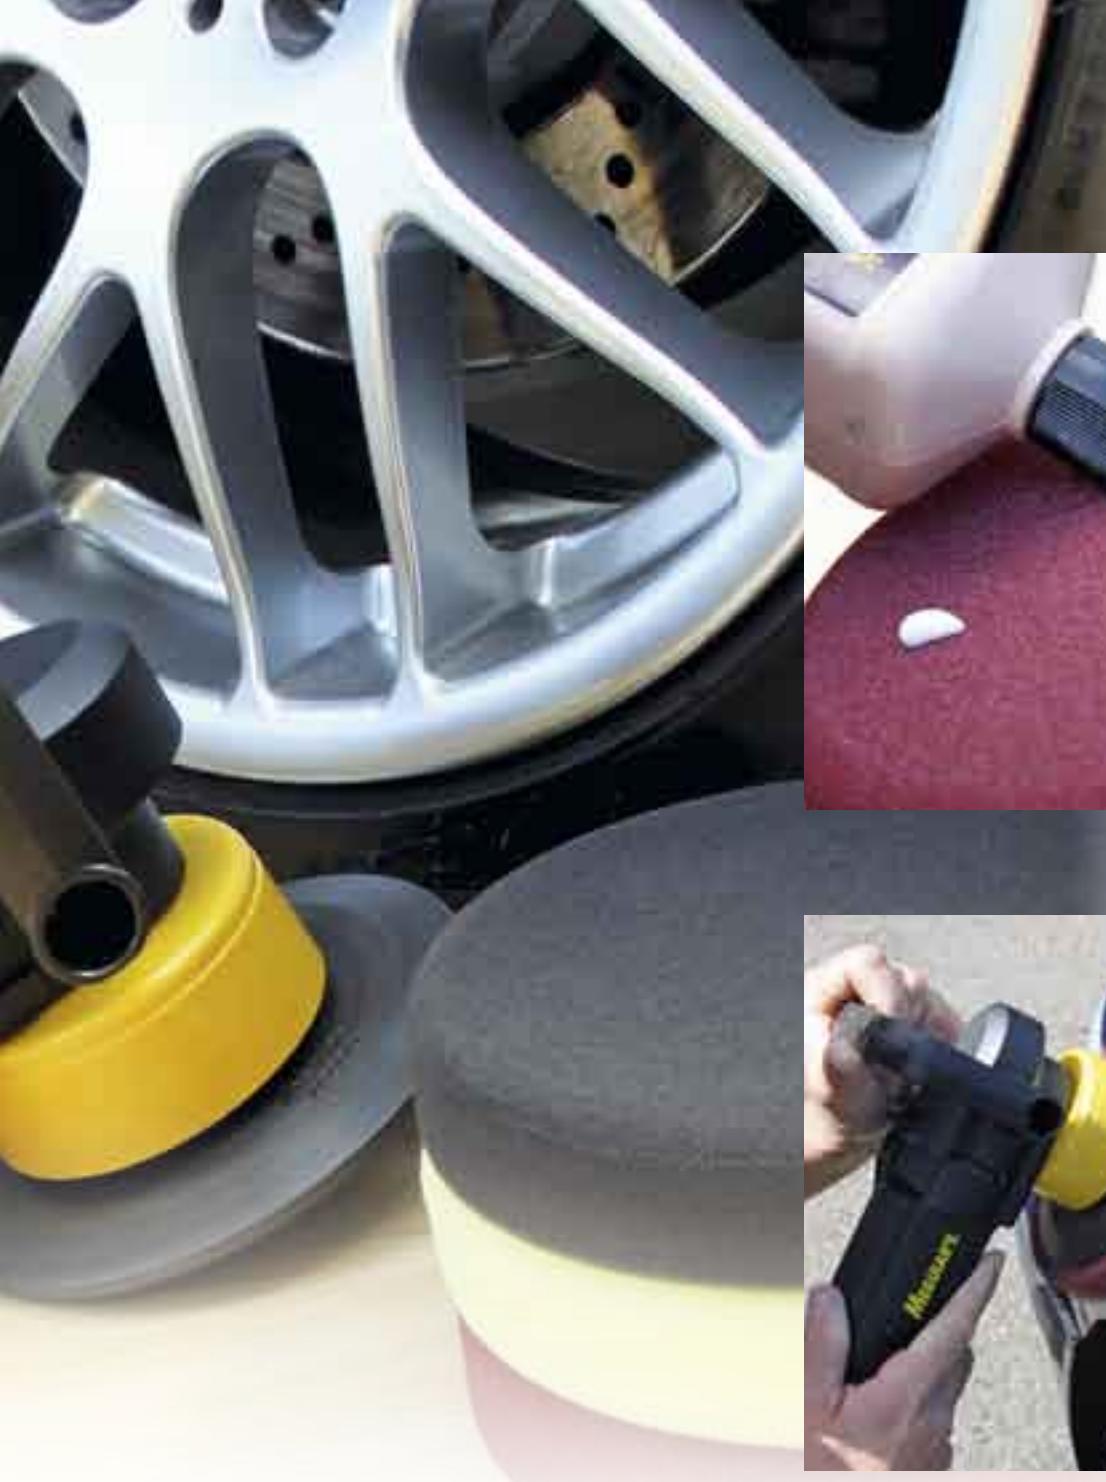
04

Using excess amounts will create the previously mentioned splatter. Three small drops of product are sufficient, but it's important not to let the pad run too dry because this will lead to an inferior finish or even permanent paint damage. The red Soft Buff cutting pad is firmer, to aid the cutting process.

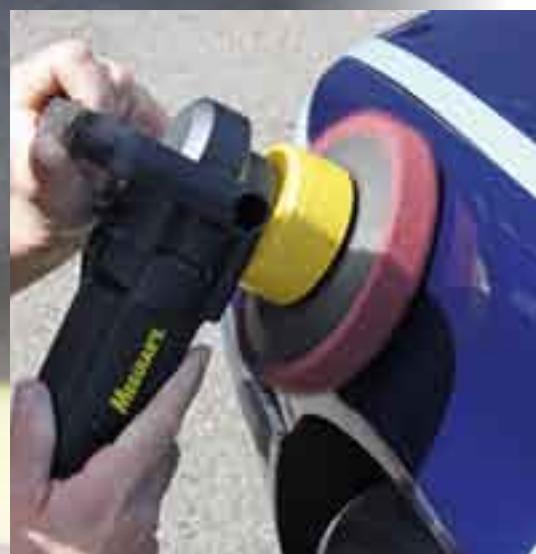
05

Avoid being too swift in your arm movements on any pass when machine polishing, but remember to keep it moving to avoid paint burn. The lower the pad speed, the more forgiving any mistakes will be (1,500-2,000 RPM rotary – higher speed dual-action setting). Buff until the product clears, then reapply.

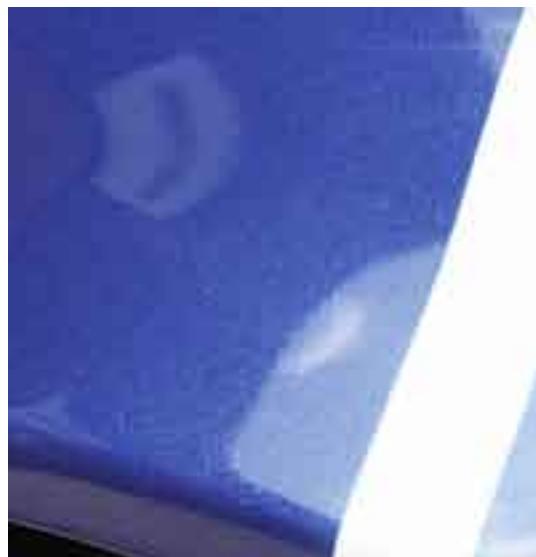
06

The flecks of metallic in the Montreal Blue came alive after just two passes with the 105 and the swirl marks have been vastly reduced. Even at this stage, the finish surpasses any application by hand.

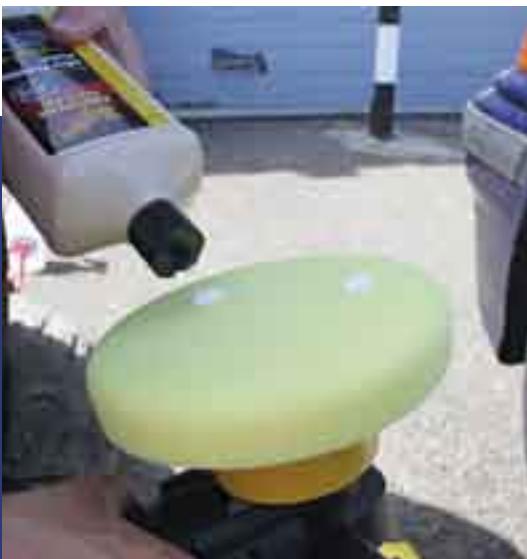
07

For the 205, a different pad was used. The yellow Soft Buff pad is softer than the previous one, but still removes minor defects while restoring gloss. The same application method and speed settings were used.

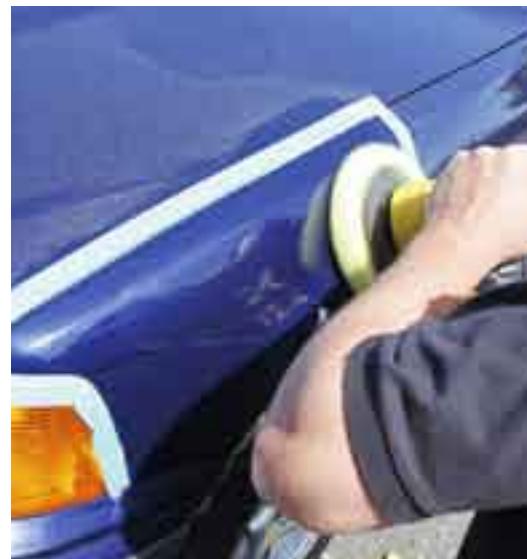
08

Take extra care when working on any ridges, swage lines or sharp curves because these are more prone to damage. The edge of the bonnet was masked up to prevent this.

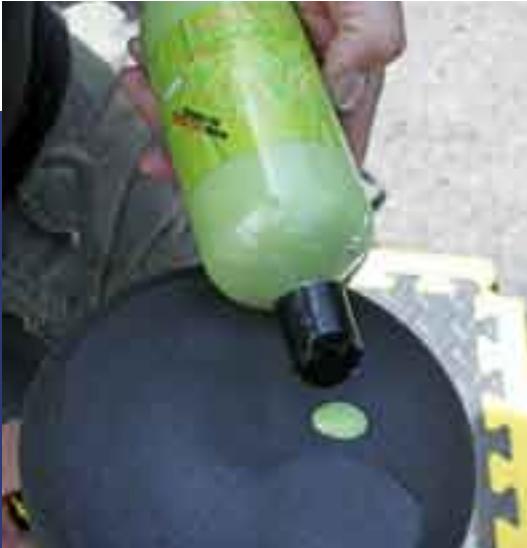
09

Before a layer of wax was applied, we used Dodo Juice's Lime Prime as a penultimate application. This continues to remove minor swirls and primes the paint for wax. Meguiar's new G220 V2 certainly reduced the chances of damaging the paint and inflicting buffer trails.

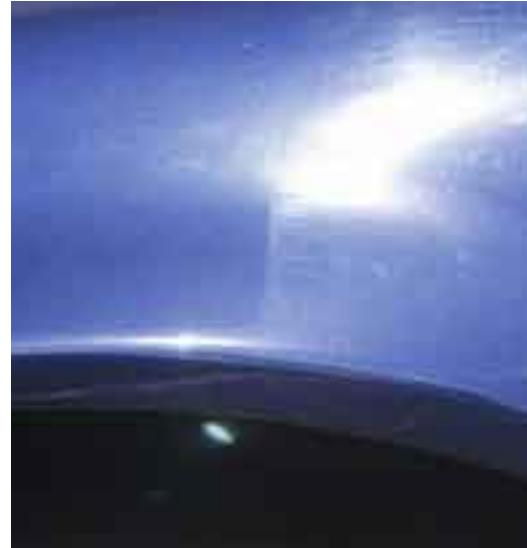
10

With the masking tape removed from the wing, the stark contrast in the paintwork could be seen. The left-hand side (after) is swirl free with an almost wet look, and the right-hand side (before) is dull and swirl-ridden.

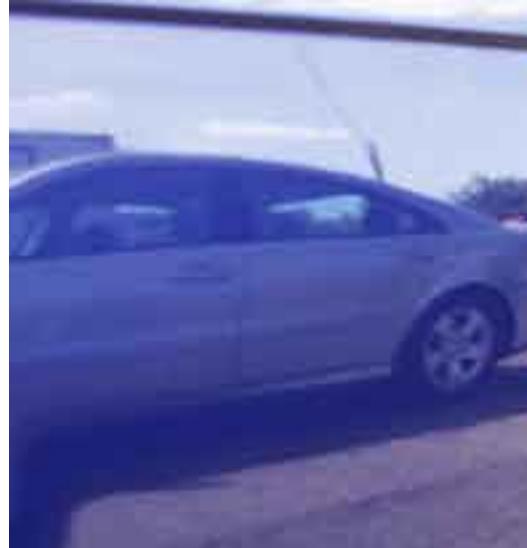
12

This Mercedes parked alongside the E36 we used for the feature could now be seen in a mirror-like reflection, whereas before it was in a haze.
